Title: STAGE 1 ROAD SAFETY AUDIT

**Proposed Residential Development at Seamount, Malahide,
Co. Dublin**

Client: Waterman Moylan

Date: October 2019

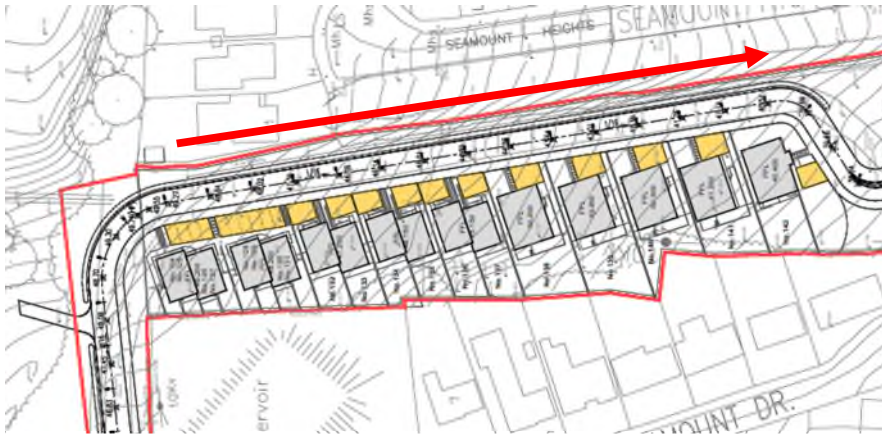
Drawings P302 & P302 Rev A. Proposed Roads and Levels layout.

The internal road leading to the new access junction on Seamount Road has a straight horizontal alignment and a steep vertical alignment (approx 6.3%). This could lead to excessive speed of both vehicles and bicycles resulting in loss of control and possible high injury severity collisions with pedestrians or roadside furniture.

It is recommended that traffic calming measures be provided along this section of the road network to prevent excessive speed.

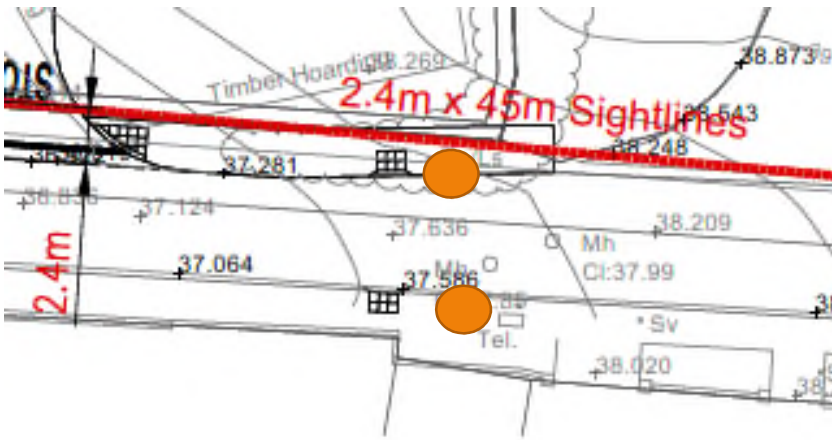
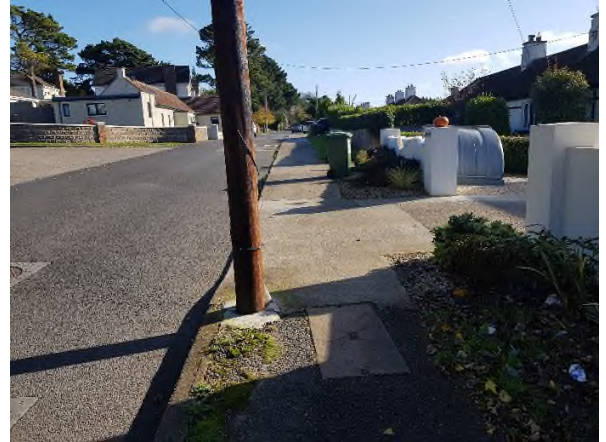
Drawing P313 Rev -, Proposed Entrance sightlines.

It is proposed to provide an informal pedestrian crossing on Seamount Road to the East of the new junction. The proposed location of the dropped kerb and tactile paving is adjacent to ESB/PL/Telecom poles. The presence of the poles could obscure visibility between pedestrians and drivers resulting in collisions with crossing pedestrians.

It is recommended that the crossing location be changed to a location where the poles are regarded as momentary obstructions or alternatively the poles should be relocated outside the required visibility envelope for crossing pedestrians.

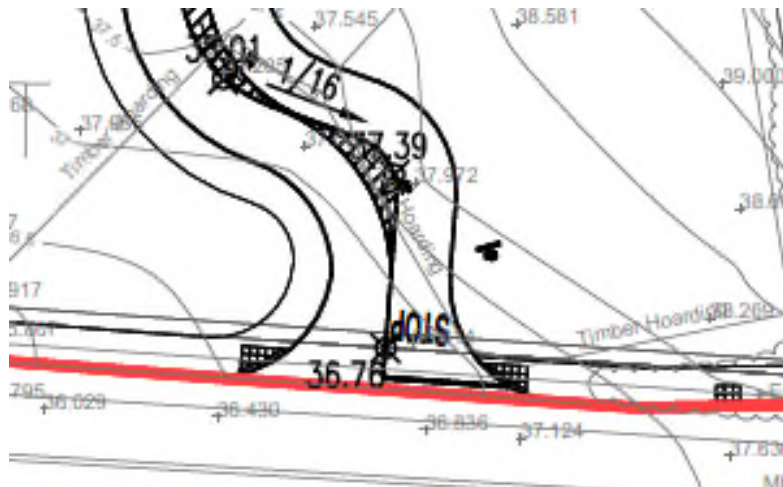
Drawing P302 & P302 Rev A. Proposed Roads and Levels layout.

It is unclear if a dwell area has been provided on approach to the new junction from within the development. If there are excessive gradients at the stop line this could result in overshoot onto Seamount Road which could result in side-impact collisions, especially in frosty conditions.

It is recommended that a suitable dwell area be provided.

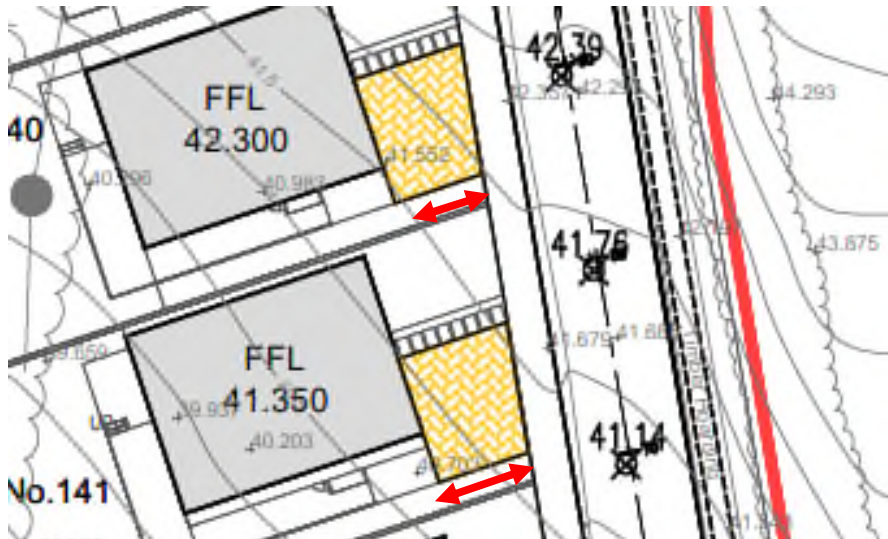
Drawing P302 & P302 Rev A. Proposed Roads and Levels layout.

Some of the parking spaces in front of the residential units on the main access road appear to be shorter than the 5m shown in the typical cross section. This could lead to vehicles overhanging the footpath resulting in pedestrians entering the carriageway where they would be at greater danger of being struck by passing vehicles.

It is recommended that a minimum of 5m parking width be provided plus a buffer zone to the residential unit.

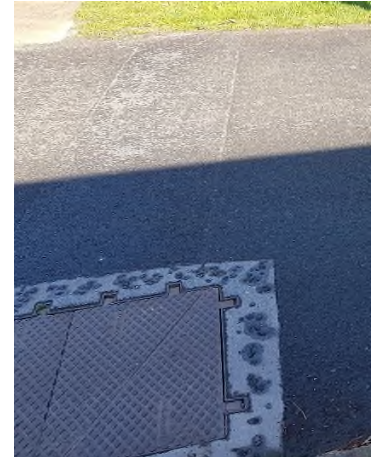
There is an Eir chamber and trench at the location of the proposed informal crossing to the West of the new access road. This could lead to trip hazards for pedestrians in the future if the lid doesn't sit properly in the frame or if the joints in the trench reinstatement crack.

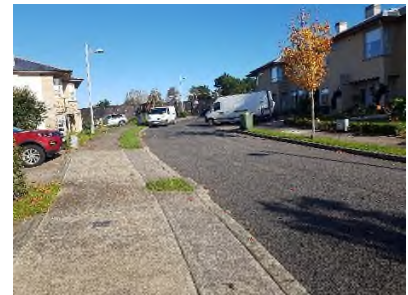
The cross section of the existing road in Seamount Abbey has a verge and a footway to the rear. The proposed extension has just a footway on both sides. The tie-in detail will have to be developed at the detailed design stage.
